Sunroof System

This information applies to the sunroof system available in the Colorado and Canyon pickup trucks.

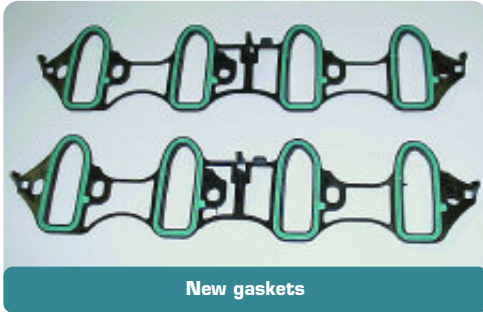
If a leak between the upper manifold and gasket causes a DTC P0300 to set, do not replace the entire upper manifold assembly, upper plenum and gaskets.

released. The new gasket material is teal green in color; the original gaskets are orange.

Use only the 89017589 gasket (teal green) for repairs on the L59 engine, and do not replace the upper manifold unless it measures outside of the service manual specifications or is damaged.

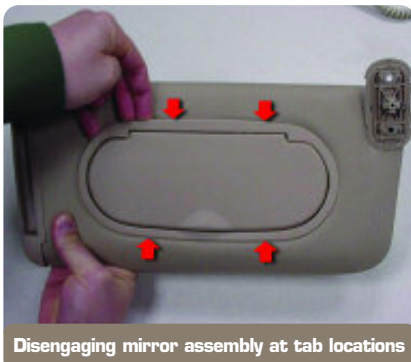
Customers may comment that the vanity mirror cover breaks during normal operation. Replace the vanity mirror assembly rather than the entire sunshade assembly.

Disengaging mirror assembly at tab locations

Insert finger tips or a plastic trim tool at the tab locations to disengage the vanity mirror assembly from the sunshade assembly.

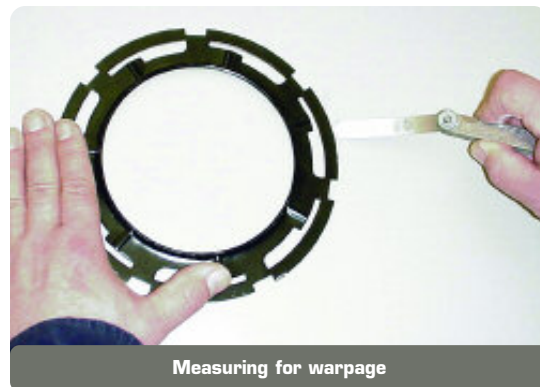
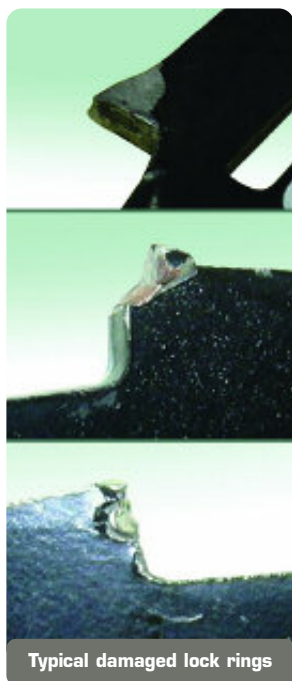
Inspection of replaced lock rings at the Warranty Parts Center indicates that numerous 130mm lock rings are being damaged and destroyed by improper installation and removal methods.

When removing the lock ring, it is important to inspect it for damage due to improper removal or installation procedures. If damage is found, install a new lock ring (or the fuel pump module in captured-ring applications). Don't replace the lock ring unless it shows damage at the tool notches or distortion greater than the 0.41mm specification.

On applications where it is possible to remove the lock ring from the fuel pump module, place the ring on a flat surface and measure for flatness. Measure even if damage is not readily visible.

1. Place the lock ring on a flat surface. Measure the clearance between the lock ring and the flat surface using a feeler gage at 7 points.
2. If the warpage is less than 0.41 mm (0.016 in), the lock ring does not require replacement.
3. If the warpage is greater than 0.41 mm (0.016 in) the lock ring must be replaced.

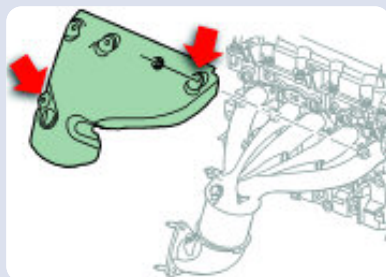
the O2 sensor and the nut on the No. 1 exhaust tube.

Inspect the exhaust manifold for a loose exhaust heat shield. Inspect all fastener positions, with emphasis on the nut above

Make sure the shield itself is not in direct contact with the manifold other than at the fastener positions. Reposition the shield if necessary to avoid contact.
