New Pre-Delivery Inspection Form Introduced

Techline News

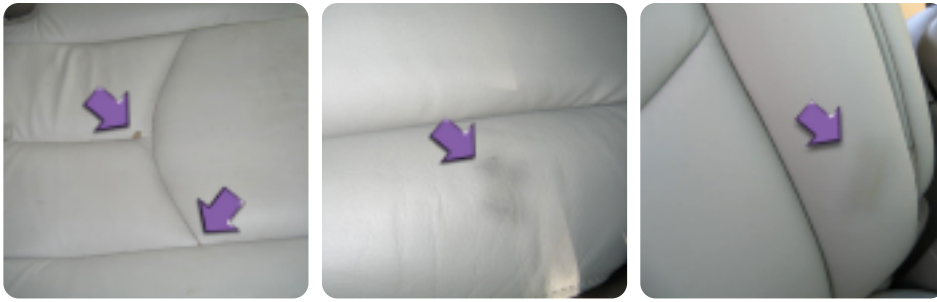
PDI – Leather Seats

Significant numbers of customers are expressing concerns in surveys about dirty seats in new vehicles at delivery. This is primarily in vehicles with leather seats, and the driver's seat is most often cited.

Seats show coffee stains, ink marks, grease marks and dirt in general. Soiling may be caused by drivers during transport from the assembly plants, by customers during test drives and vehicle evaluations, or by dealership personnel moving the vehicles while at the dealership.

Regardless of the cause(s), seats must

be inspected as a part of the pre-delivery inspection, and cleaned as necessary before delivery.

TIP: The owner's manual recommends a soft cloth moistened with mild soap and water.

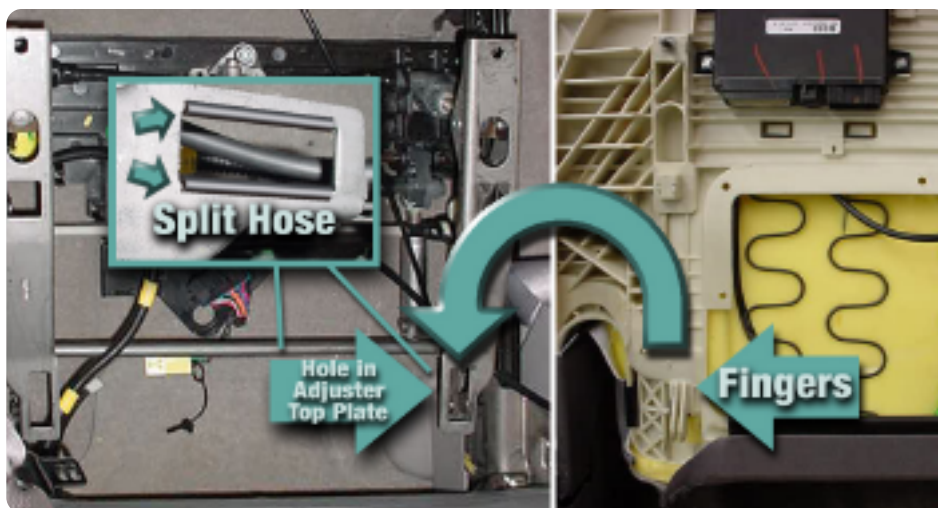
Seat Clunk

When making turns, owners of some 2004 Buick LeSabres may hear a clunk or feel seat movement.

Under these conditions, the "fingers" on the seat bottom tray can move laterally in the rectangular hole in the adjuster top plate.

To reduce play and dampen noise, split a small piece of rubber vacuum hose and install on the edges of the rectangular hole in the adjuster top plate to reduce the clearance between the plastic seat bottom tray fingers and the metal adjuster top plate.

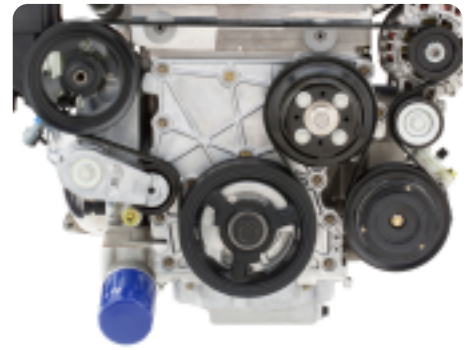
Cracked Serpentine Belt

All current GM vehicles designed and manufactured in North America were assembled with serpentine belts made with an EPDM material and should last the life of the vehicle. It is extremely rare to observe any cracks in EPDM belts and it is not expected they will require maintenance before 10 years or 150,000 miles (240,000 km) of use.

Older style belts, which were manufactured with a chloroprene compound, may exhibit cracks depending on age. However, the onset of cracking typically signals that the belt is only about half-way through its usable life.

A good rule of thumb for chloroprene-based belts is that if cracks are observed 1/8-inch (3 mm) apart, all around the belt, the belt may be reaching the end of its serviceable life and should be considered a candidate for changing. Small cracks spaced at greater intervals should not be considered as indicative that the belt needs changing.

TIP: Any belt that exhibits chunking should be replaced.

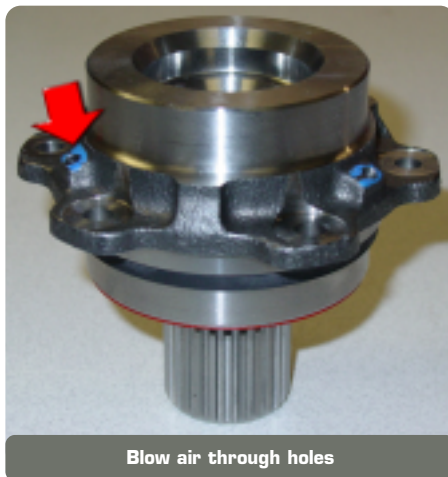
Blow air through holes

On some 4T80E transmissions, used in 2003 DeVille, Seville and Aurora, the drive sprocket support oil holes may not be completely drilled. The converter seal may be dislodged and/or the spring may be mispositioned. Symptoms include oil leaks in the converter area.

Replacing the converter seal alone may not correct the condition. Inspect the drive sprocket support for completely drilled oil holes. Blow compressed air through holes and listen for airflow out of the converter spline side. If the holes are not drilled, replace the drive sprocket support.
