## Corvette Z06 Dry Sump Oiling System

## Techline News

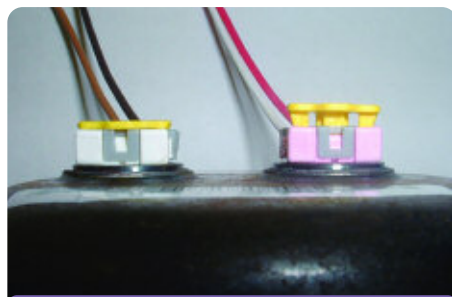
Locked position (left) and Pre-Locked position (right)

**IMPORTANT:** Do not pull the CPA completely out of the connector. If the CPA is removed completely from the connector assembly, it will be damaged and must be replaced with a new one.

**TIP:** Replacement CPAs will be available in the SIR tray in the terminal repair kit (J-38125) later this year. Until available, if the CPA needs to be replaced, order part number 88988974 RETAINER, INFL RST WRG HARN CONN (CPA AT DRIVER AIRBAG).

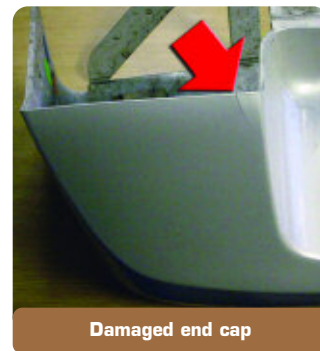
The 8 fasteners that secure the boards to the vehicle must be loosened before installing the end caps. Loosening the boards helps install the end caps without stress on the part and allows for proper alignment to the vehicle. Failure to properly align the board to the vehicle during end cap installation will cause the end cap to crack.
