SPS Applications

Techline News

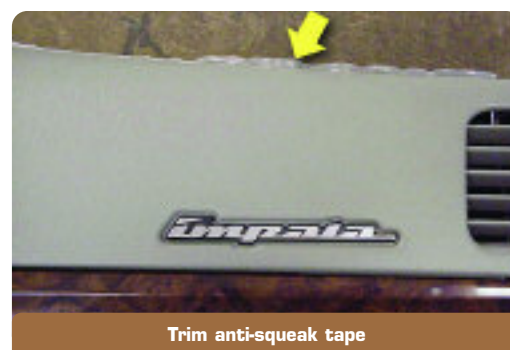
Anti-squeak tape is used as an isolator between the trim plate and the I/P top pad. This tape has been identified as a source of a gap appearance, when the tape begins to release from the trim plate and the adhesive side of the tape shows between the parts.

Bulletin 04-08-110-007 recommends trimming the tape at the upper edge.

TIP: DO NOT remove or cut the tape with the trim plate attached.

Allow enough of the tape to remain on the trim plate edge contacting the topper pad, but trim so it no longer shows between the parts. This will prevent the unnecessary replacement of the entire I/P trim plate for gap appearance.

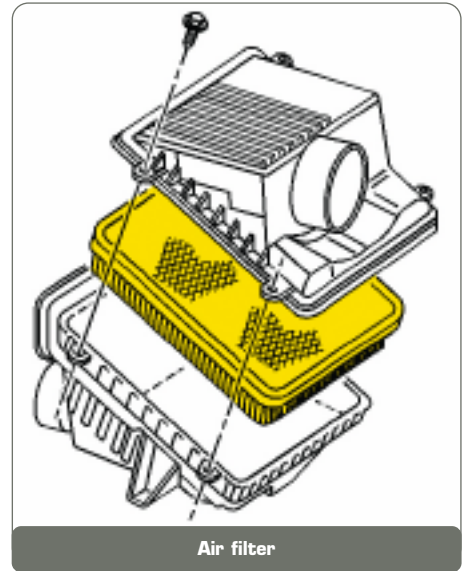
Air filter p/n 25332443 is specific to the Duramax diesel engine. It is reinforced to eliminate damage from the increased airflow of the turbocharger. The reinforcement is visually identified by five ribs of epoxy across the pleats of the clean side of the filter.

TIP: The 8.1 liter gasoline engine air filter p/n 25313349 should never be used with a Duramax diesel. It will fit into the air box; however, it does not have the required reinforcement of the diesel air filter.

Due to the greater airflow possible with the turbo, an incorrect air filter may collapse or be torn, allowing dust and dirt to be ingested. This can cause serious damage to the turbo vanes and cylinder walls of the engine.

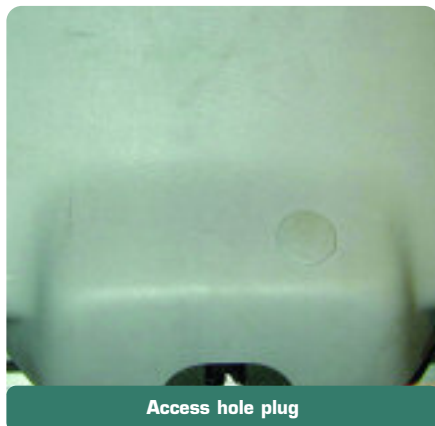
Access hole plug

The 2002 and newer Chevrolet TrailBlazers, GMC Envoys, Oldsmobile Bravadas and Buick Rainiers are equipped with a service access hole in the event the liftgate latch will not unlock due to a loss of power. The access hole is located near the liftgate latch.

To unlock the liftgate from inside the vehicle, expose the access hole by removing the round plug. Then, unlatch the glass lock lever (located toward driver's side). With the glass unlocked, the liftgate release lever (located toward passenger side) can be operated.

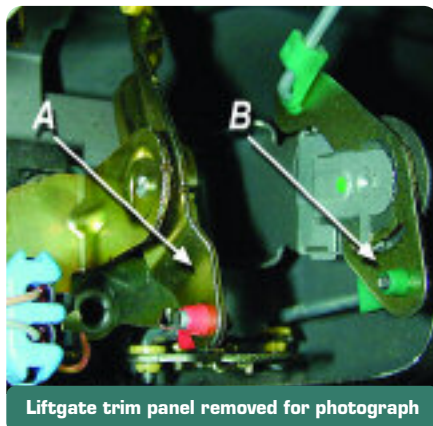
Liftgate trim panel removed for photograph

- A Liftgate release lever
- B Glass lock lever

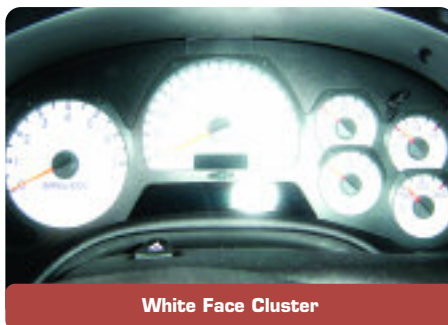
White Face Cluster

Some customers may comment that the instrument panel cluster is hard to read during sunlight hours on 2005 Chevrolet TrailBlazer and EXT Models built before October 12, 2004.

The white background of the instrument cluster is the cause. Refer to service bulletin 04-08-49-028 or SI document 1560970 for black face cluster exchange information to resolve this condition.

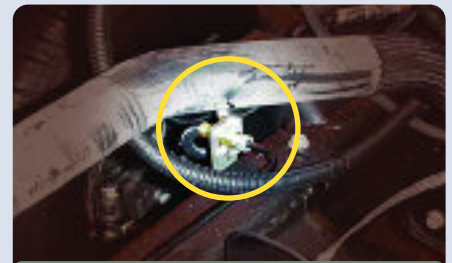
On some 2004 Chevrolet Express and GMC Savana with a 4.3L engine, there may be a coolant leak from the lower radiator hose.

Hose contacting clip

Replace the lower radiator hose as needed. Then, reposition the left front brake hose retaining clip. Rotate the clip 90°, so the flat part of the clip is at the top.
