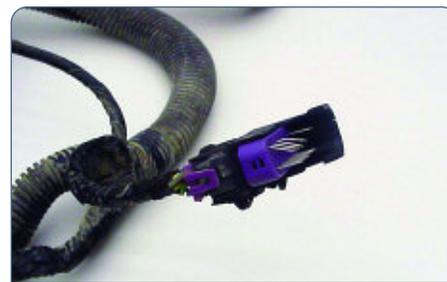
Damaged connector and terminals can be replaced

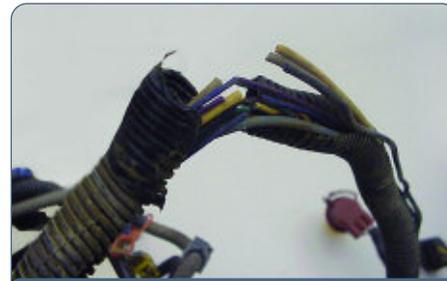
Cut wires can be spliced

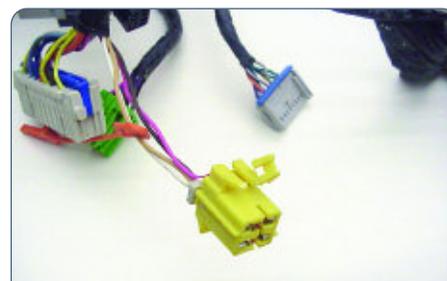
SIR connector can be replaced with pigtail

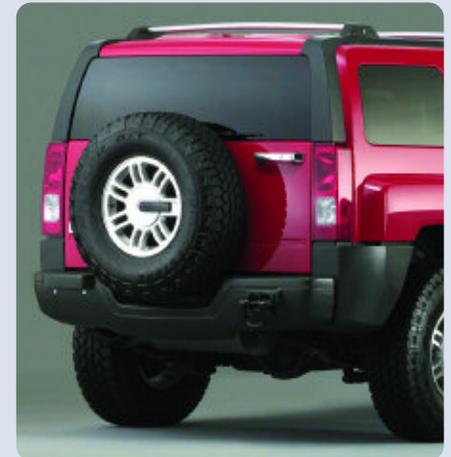
On some Hummer H3s, the warning chime may sound intermittently, the dome lamp may come on and/or the door locks may cycle. This typically occurs when going over bumps or accelerating. The cause may be the adjustment of the swing gate closing switch.

TIP: This input is for all of the passenger doors. It may be necessary to disconnect the swing gate ajar switch to verify it is the source of the concern.

If the concern is isolated to the swing gate ajar switch, apply a sticky backed rubber or plastic patch approximately

3 mm thick to the swing gate inner panel where the switch contacts the door.

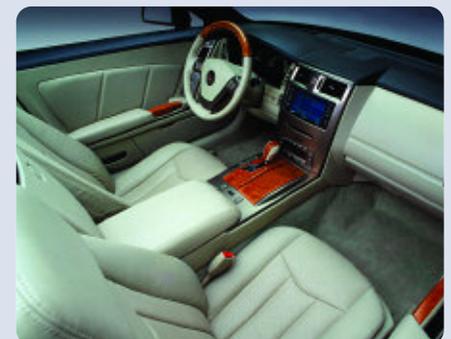
Owners of some 2004-06 Cadillac XLRs may comment that the interior of the vehicle is turning pink. The concern may be seen on door panels, the driver's knee bolster and passenger's glove box. The concern is mostly apparent on vehicles equipped with the Shale interior (RPO 15I). The condition is linked to vehicles that are stored in the winter months in a warehouse that uses propane fork lift (hi-lo) vehicles. The dye of the interior reacts to high concentrations of combustion by-products and turns to a pink tint.

isopropyl alcohol and water. Exposure to natural sunlight for 2-3 hours will completely remove the pink coloration.
