Proper Terminal Removal Procedures for the Delphi .64 Connection System

Proper Terminal Removal Procedures for the Delphi .64 Connection System — from page 1

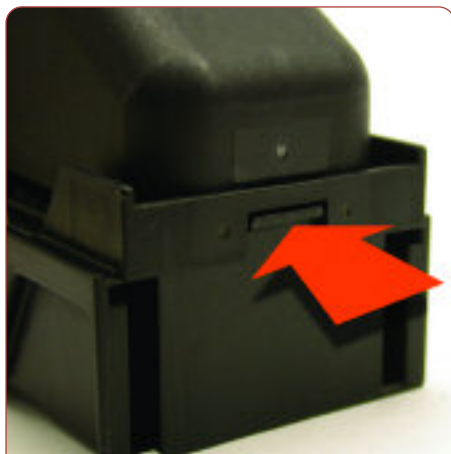
Single tab version

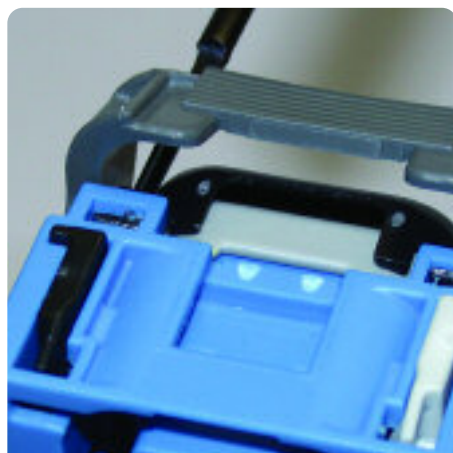
Loosening tab on two-tab version

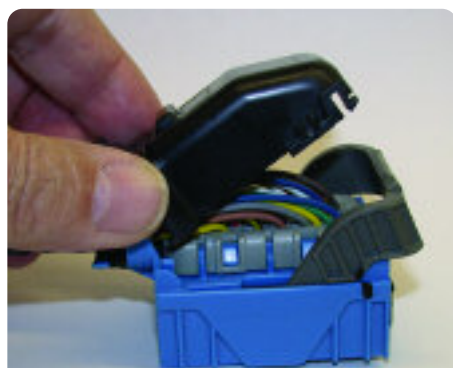
Rock cover up and off

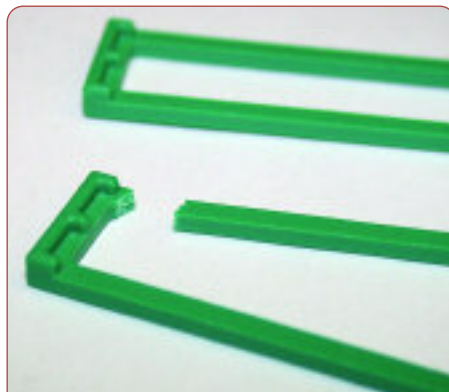
The next step is removal of the comb style TPA (Terminal Position Assurance). Be very careful, because the TPA can break very easily, particularly if you try to pry the head of the TPA out of the connector.

Broken TPA

On Type 1 connectors, push the TPA from the end of the connector opposite the head. This will get the TPA past the detent that retains it in the connector. Then grasp the head and pull the TPA out of the connector.

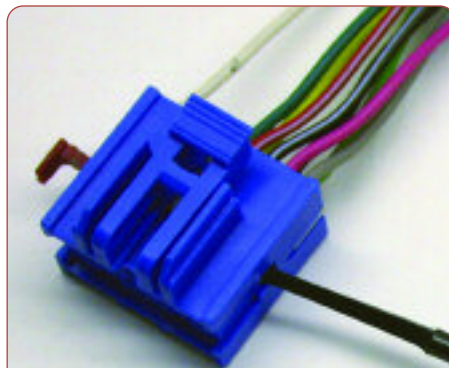
Pushing TPA from Type 1 connector

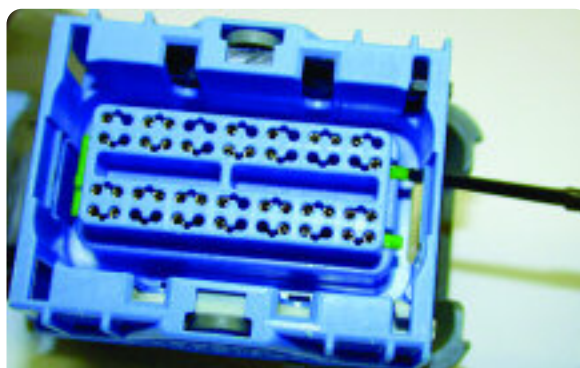
Loosening TPA on Type 2

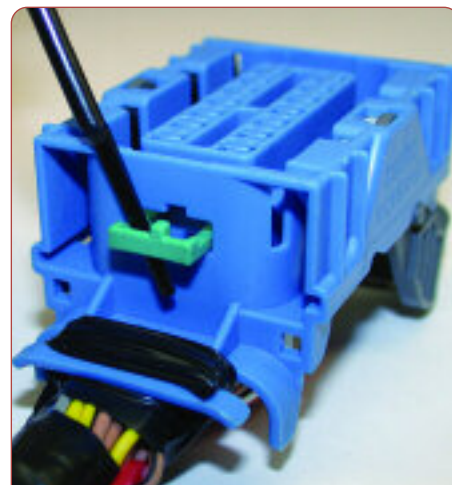
Removing TPA

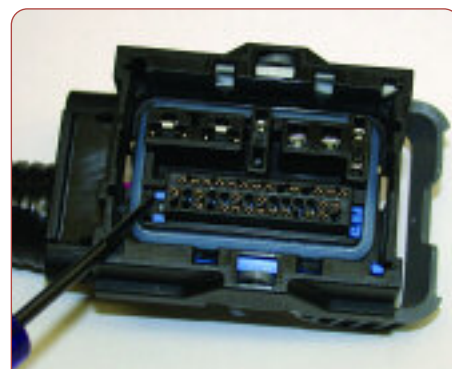
Levering the TPA loose in Type 3

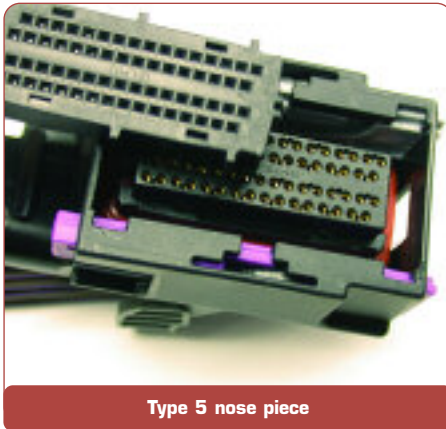
Type 5 nose piece

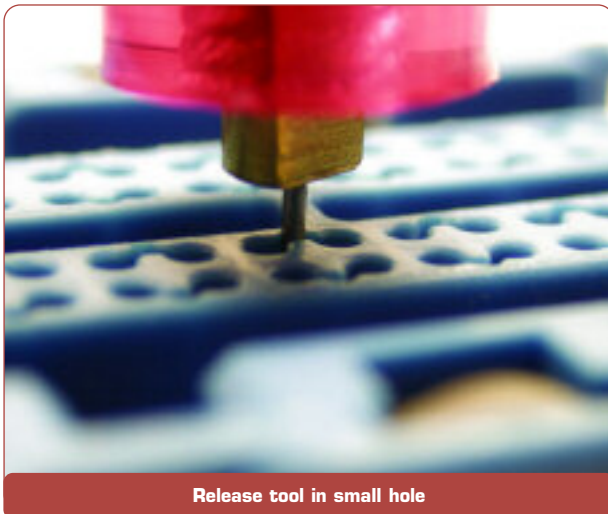
Release tool in small hole

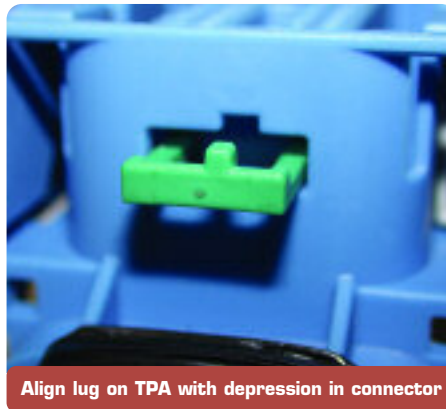
Align lug on TPA with depression in connector

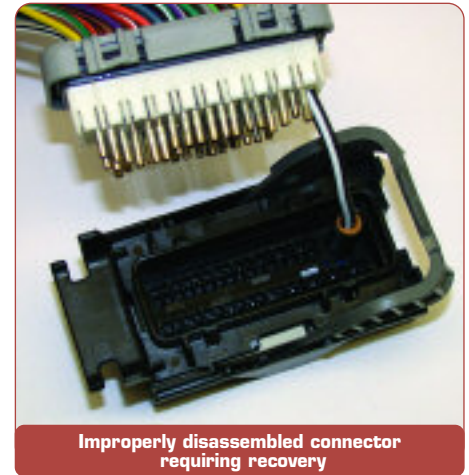
Improperly disassembled connector requiring recovery

Remove all the wires with their terminals from the connector. Reassemble the connector, leaving the TPA and wire dress cover off. Using the Connector End View information in SI, reassemble the wires into the connector, starting with the shortest wires and ending with the longest. Once the circuits have been correctly placed

into the connector, replace the TPA and dress cover.

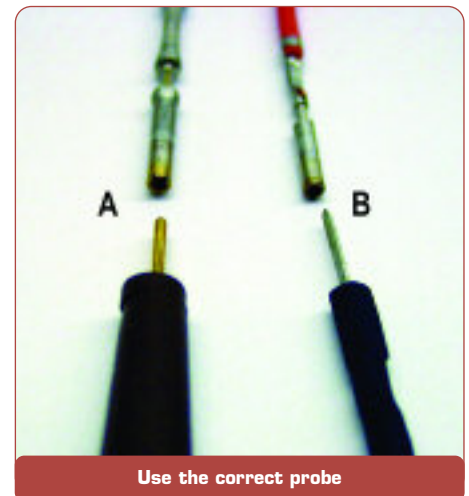
not withstand excessive probing, especially with an incorrect tool. The ability of the J-35616-64A Test Probe to "hang" in a round type .64 terminal will be minimal. The drag that you feel is much less than you're accustomed to in a larger terminal.

Use the correct probe
