## Fuel Tank System Corvette and Cadillac XLR

## Techline News

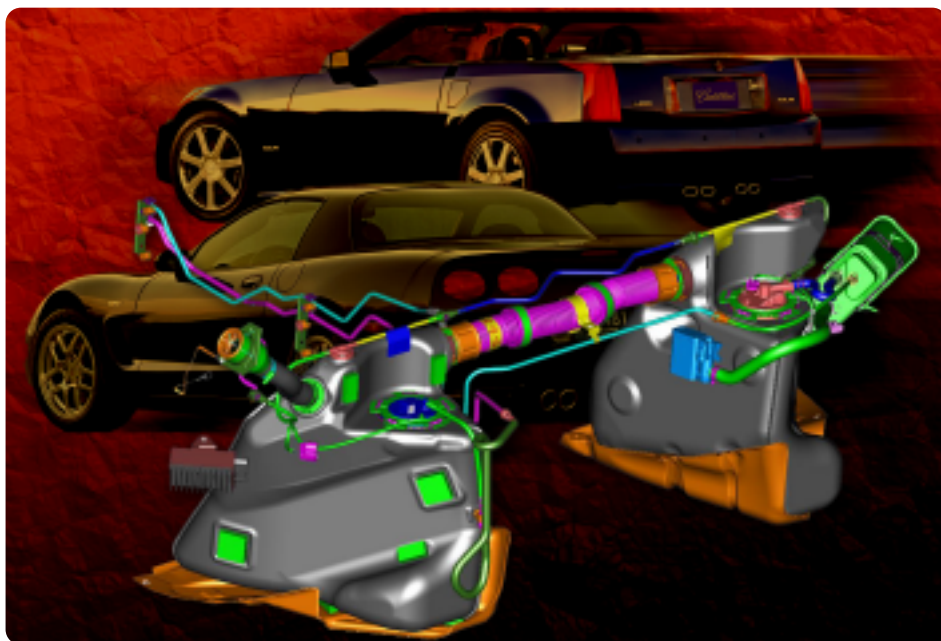
joined by crossover plumbing. The left side (driver side) tank (A) is considered the primary, and the right side (passenger side) is secondary (B).

Each tank contains a sensor module, which includes a float and resistor card.

On the left side, the sender module includes a reservoir (C), containing the turbine fuel pump (D). There's also a primary fuel pressure regulator and a venturi pump (E). The left tank is also supplied by the fuel fill hose (F), and has a rollover vent valve.

On the right side, the sender module contains a secondary fuel pressure regulator (G) and a siphon jet pump (H). There is also a fill limiting vent valve (FLVV) (J).

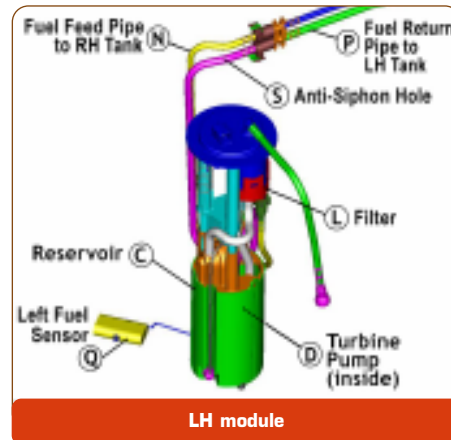
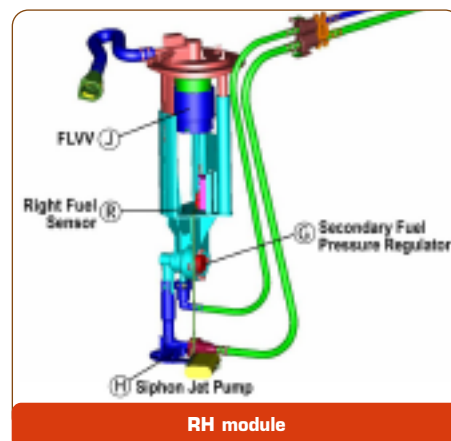
Each fuel tank has its own sensor (Q and R in the illustration). The PCM supplies a reference of 5 volts to the two sensors. Each sensor operates across a range from full (2.5 volts) to empty (0.7 volts). The PCM monitors the fuel level sensor voltages and calculates how much fuel is in the two tanks. The read-out of the IP fuel level gauge is a result of this calculation.

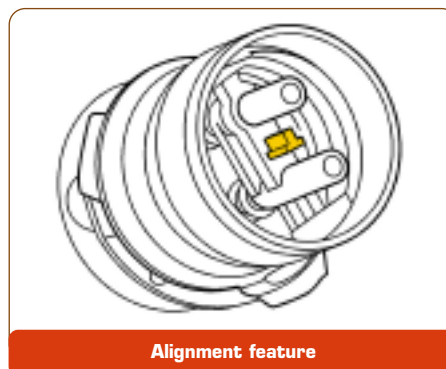
**TIP:** There is a T-shaped alignment feature between the feed pipes which can be assembled only one way.

With the crossover in place, turn the collar. If the crossover and pipes are properly aligned and assembled, the collar can be turned with two fingers. Then snap the CPA into place.

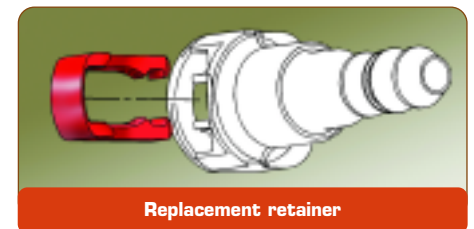
**TIP:** To release, push on the retainer using hand pressure only. Do not attempt to remove it.

If the retainer becomes broken, it can be replaced using the following part number.
