Proper Terminal Removal Procedures for the Delphi .64 Connection System

Proper Terminal Removal Procedures for the Delphi .64 Connection System — from page 1

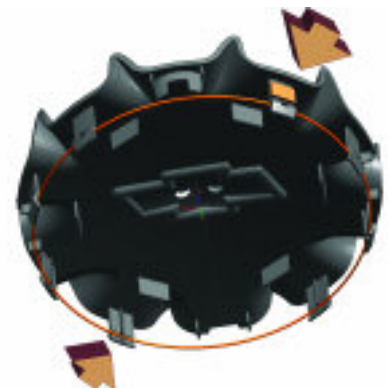
SSR Center Caps Loose – Update

An article in the December 2004 TechLink explained how to repair center caps that are loose and rotate, then do not align with the wheel spokes.

According to PIT3196A, the tape is now available by filling out the template at the bottom of the PI and faxing it to the WPC. The WPC will send out a service kit that consists of 8 pieces of polyurethane tape (2 pieces per wheel). The part number of this kit is TAC 306.
