Sunroof System

This information applies to the sunroof system available in the Colorado and Canyon pickup trucks.

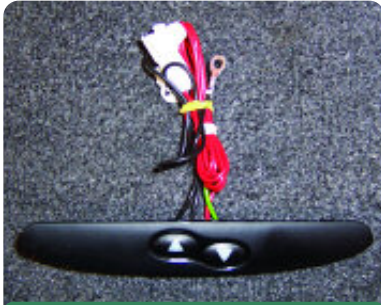
Sunroof switch and bezel

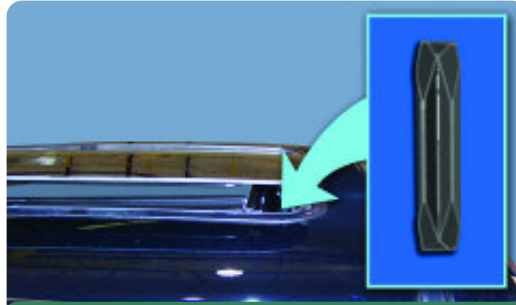
The glass travels from closed to vent to full open position, and can be stopped in any position by releasing the sunroof switch. As the glass reaches the open or closed limits, mechanical hard stops inhibit the travel. The mechanical hard stops stall the motor into an over-current condition, as an internal motor device opens. Operation will resume once the over-current condition is removed, by releasing the sunroof switch.

Mechanical hard stops limit travel.

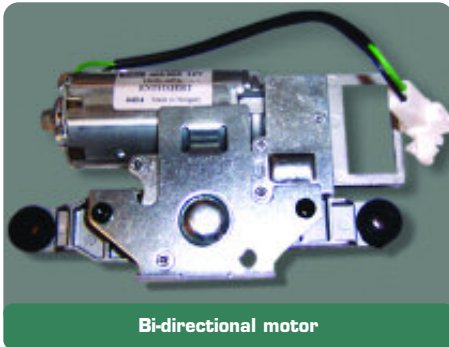
The motor is bi-directional, and the direction of motor rotation is determined by which of the motor

control circuits is switched to positive voltage while the other remains grounded.

Bi-directional motor

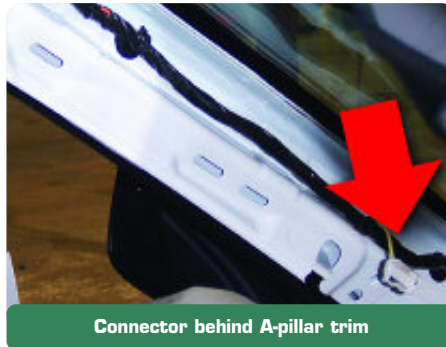
The in-line connector supplying the ignition voltage to the sunroof switch is located behind the left A-pillar trim.

Connector behind A-pillar trim

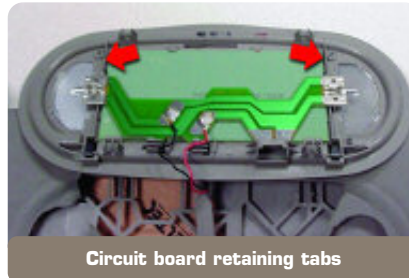
Circuit board retaining tabs

Remove the circuit board from the vanity assembly.

TIP: Slightly flex the vanity mirror assembly to release the circuit board from the retaining tabs.

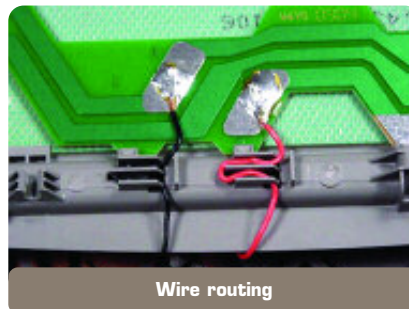
Wire routing

Install the circuit board to the new vanity assembly and route the wire leads through the wire guides.

Snap the vanity mirror assembly into the sunshade assembly and install sunshade to the vehicle.
