## Fuel Tank System Corvette and Cadillac XLR

## Techline News

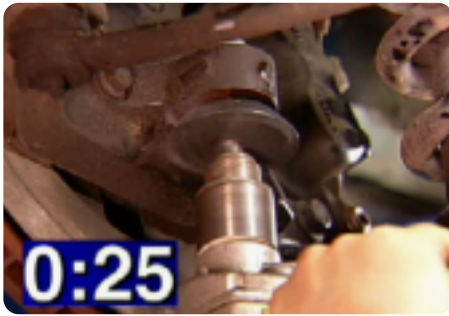
Product Recall Bulletin 03044 has just been released, to explain a steering knuckle modification on 2003 Chevrolet Astro and GMC Safari 2WD M-vans.

This bulletin is being supplemented with a narrated video, available on SI.

This is a new method of delivering recall information. It allows you to actually see the repair being performed, using the special tools called for in the bulletin.

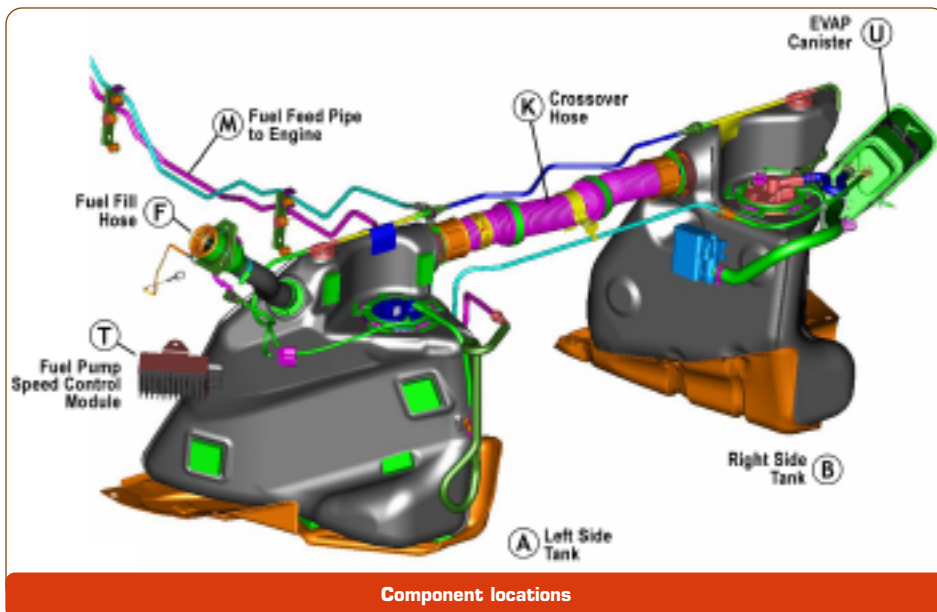
When the fuel tanks are filled, fuel first fills the left tank. As the fuel rises to the level of the crossover (K), fuel flows into the right tank. As fuel occupies the inter-connected tanks, air is forced to vent from the tanks, through the FLVV in the right tank. When both tanks are full, the FLVV float in the right tank closes, preventing fuel from entering the vent system. This also causes fuel to back up in the fill hose, causing the gas pump nozzle to shut off.

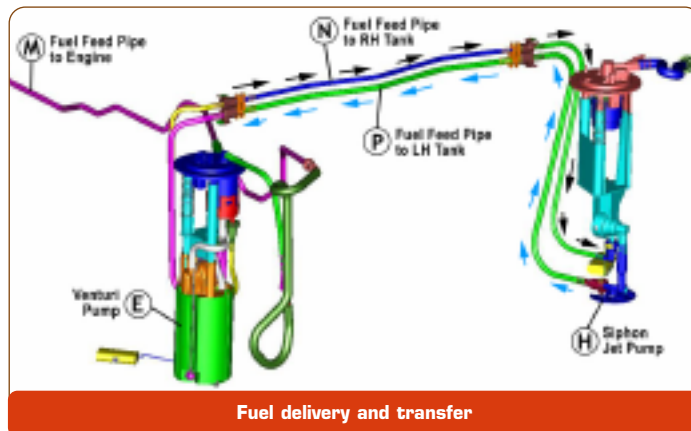
Some of the pressurized fuel is directed through a feed pipe (N) inside the crossover hose, to a siphon jet pump in the right tank. The jet pump relies on the venturi effect to use pressurized fuel to draw additional fuel from the tank. The combined fuel then flows from the right tank to the left tank, through a return pipe (P) inside the crossover hose. The

jet pump is able to move enough fuel to ensure that all of the fuel in the right tank is consumed before the level in the left tank begins to drop.

**TIP:** The return tube in the left tank has an anti-siphon hole (S), so the fuel in the left tank does not siphon back to the right side when the vehicle is shut down.
