Pro-Cut Brake Lathe

Techline News

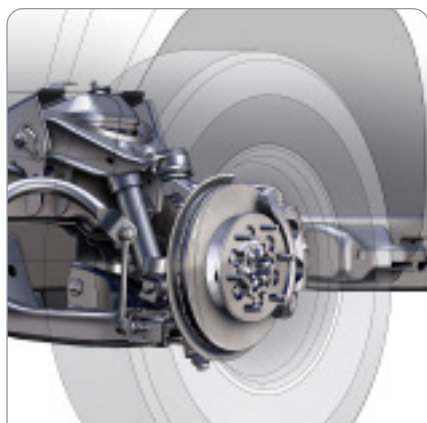
Typical captured rotor

The Colorado/Canyon introduces a new brake design called "captured rotor." Here, the wheel is mounted to the wheel studs on the front side of the hub, the same as before. But the brake rotor is bolted to the back side of the hub and is retained by separate fasteners.

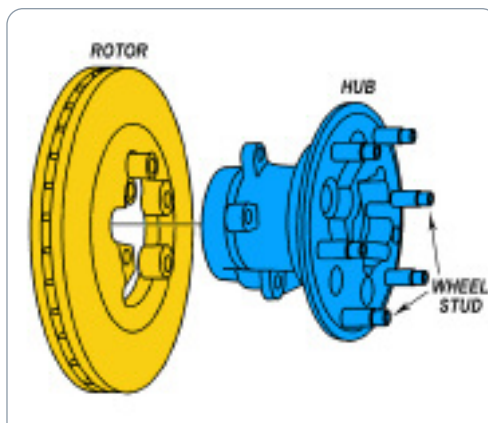
Captured rotor components

1. Rotor removal requires removal of not only the wheel, tire, and brake caliper, but also the hub/bearing assembly, which contains the ABS sensor and wiring. Then the rotor is removed from the backside of the hub.

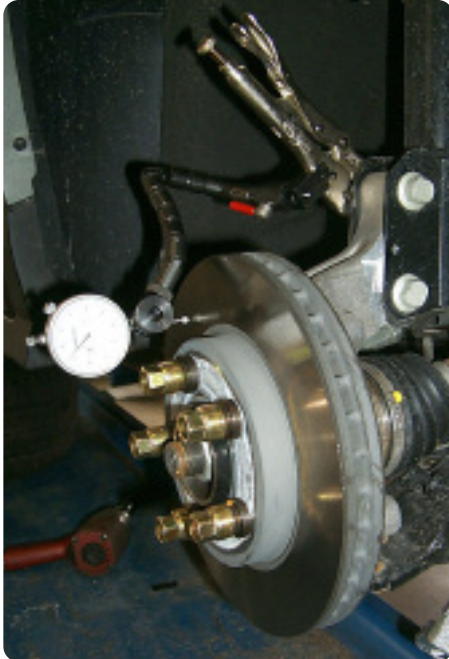
Brake Rotor Lateral Run Out (LRO)

Excessive LRO results in intermittent contact between the brake pads and rotor. Intermittent contact causes uneven rotor wear (thickness variation), which causes the piston to pump in and out of caliper when the brakes are applied. The customer senses this as brake pulsation through the brake pedal. For this reason, GM has established a total indicated run-out spec of 0.002-inch (0.050 mm) or less for all vehicles.

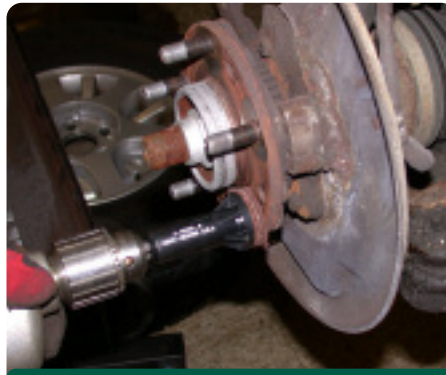
Cleaning – As with any brake job, on-car turning requires that all mating surfaces be clean and free of corrosion. Use J-42450A to clean the hub flange around the wheel studs, and use J-41013 to clean the hub/rotor mating surfaces.

Cleaning mounting surfaces

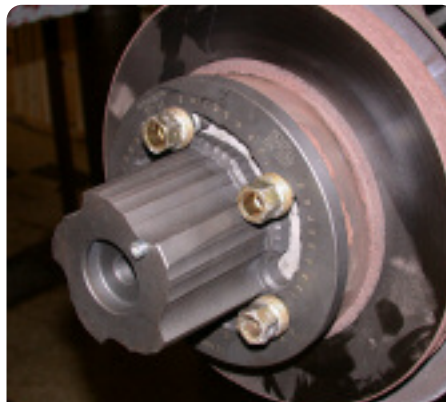
Tool Installation – Select the proper direct-fit adapter from the four that are included with the Pro-Cut, attach to the vehicle using the lug nuts, and torque properly. Attach the Pro-Cut to the adapter and tighten the retaining knob.

Direct Fit Adapter

TIP: When the Pro-Cut is attached to the vehicle, it is supported by the vehicle's wheel hub. The Pro-Cut carriage is used only to hold the lathe when not in use, and to assist in positioning the lathe to the wheel hub.

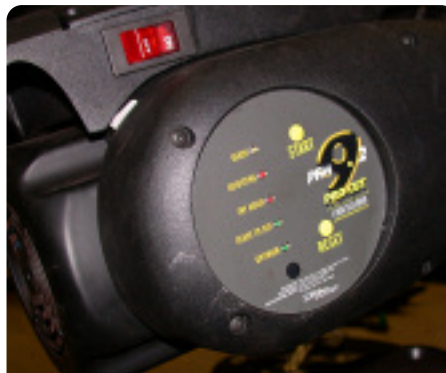
Auto-Compensation – Run the built-in auto-compensation routine. This aligns the lathe to the hub centerline, to ensure an accurate cut. An indicator lamp tells when this has been accomplished.

Indicator lights

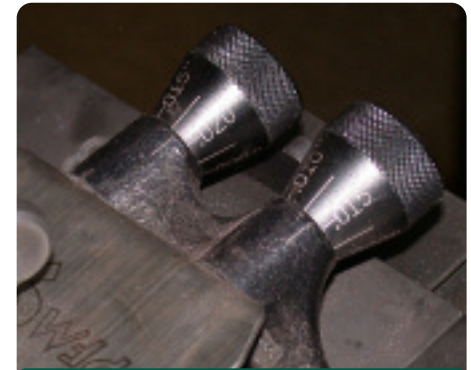
Rotor Turning – Take three scratch cuts to determine the required depth of cut. The Pro-Cut is equipped with micrometer controls. Once the cutters have been set, run the Pro-Cut to automatically turn the rotor.

Micrometer adjusters

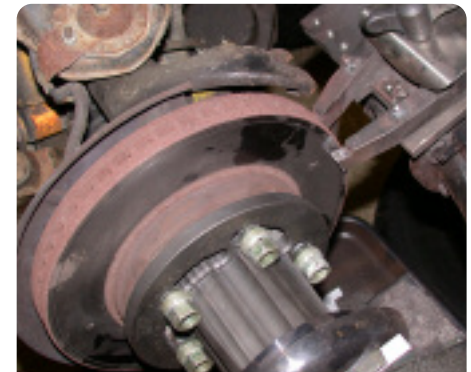
Turning the rotor automatically

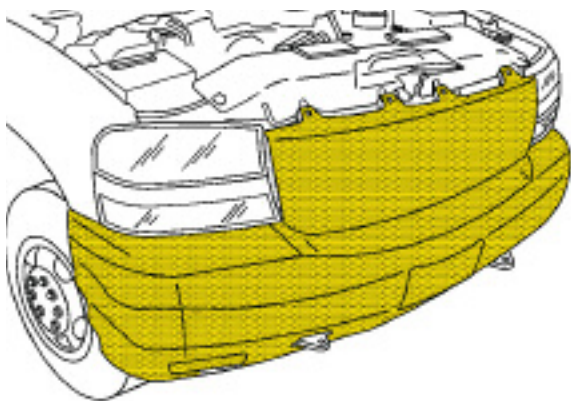
The cover installs over the front bumper and restricts airflow to the engine compartment.

Installing the winter cover enhances heater performance and reduces the amount of time it takes to warm the inside of the vehicle when the temperature is below 0°F (-18°C).

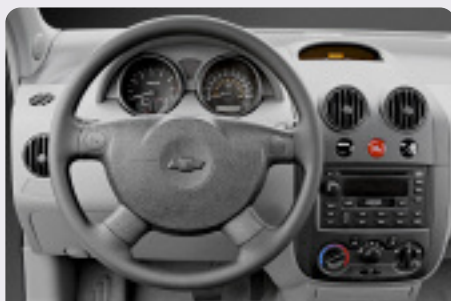
Aveo Instrument Panel

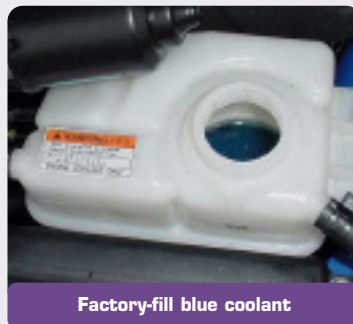
Factory-fill blue coolant

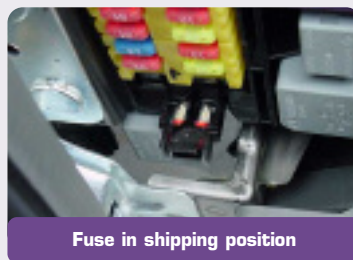
Fuse in shipping position

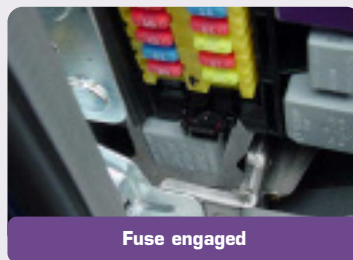
Fuse engaged

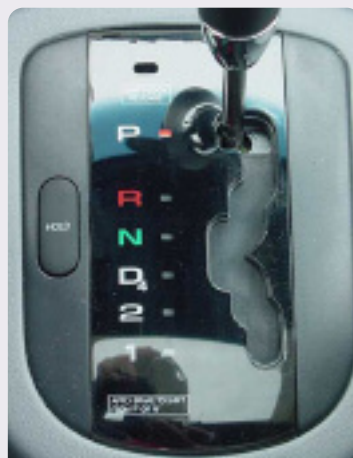
Press knob down to shift
