Generation 6 OnStar

OnStar launched new and improved Generation 6 hardware in March, as a mid-year change on the vehicles listed in the accompanying table. New OnStar hardware is labeled *System Type: Analog/Digital* on the window sticker. Other vehicles will roll out throughout the 2004 calendar year.

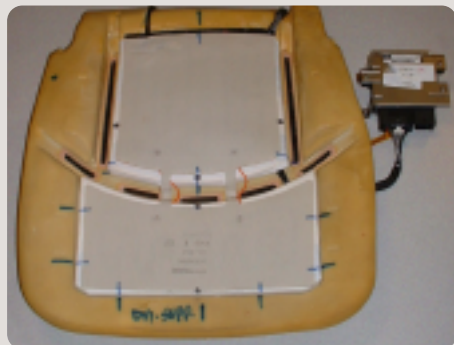
strips placed underneath the seat cushion trim and attached to the top surface of the bottom seat cushion foam. These sensor strips transmit and receive a low-level electric field. The weight of the occupant sitting in the front passenger seat is measured as a change in current flow within the sensor mat. The ECU algorithm uses this change in current flow to determine the classification of the occupant.

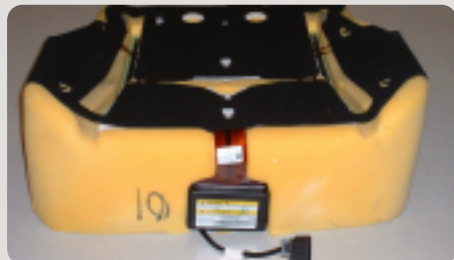
The PPS consists of an electronic control module, sensor mat, wiring harness, and passenger air bag status indicators.

The sensor mat is attached to the top surface of the bottom seat cushion foam and is made up of many very thin force-sensing resistors, strategically located across the surface. From these positions, this system can detect the size and shape of the object in the seat. As the seat is loaded, the resistance through cells lowers and the voltage through the mat changes. From this, the ECU monitors the pressure profile of the occupant to determine the proper classification.

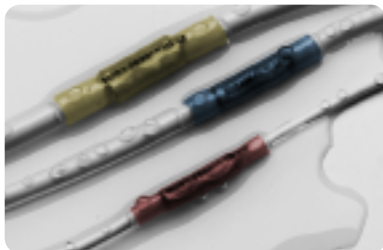
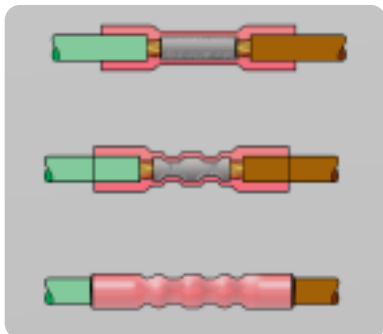
Take a look in Tray 1 of your J-38125 Terminal Repair Kit. Three of the bins contain pink, blue and yellow DuraSeal Crimp and Seal splice connectors. Each is identified by its own part number and is suitable for splicing wires of a specific gauge. See the table below for details.

Crimp and Seal splices are intended to join wires located in areas that are subject to harsh environmental conditions such as temperature extremes, immersion in fluids such as coolants, oil, and water, and exposure to ultraviolet radiation.
